Keep on truck

When the COVID-19 crisis dramatically reduced flights at Stansted, the airport replaced aircraft with trucks to bring forward some scheduled maintenance work. **Tom Allett** explains

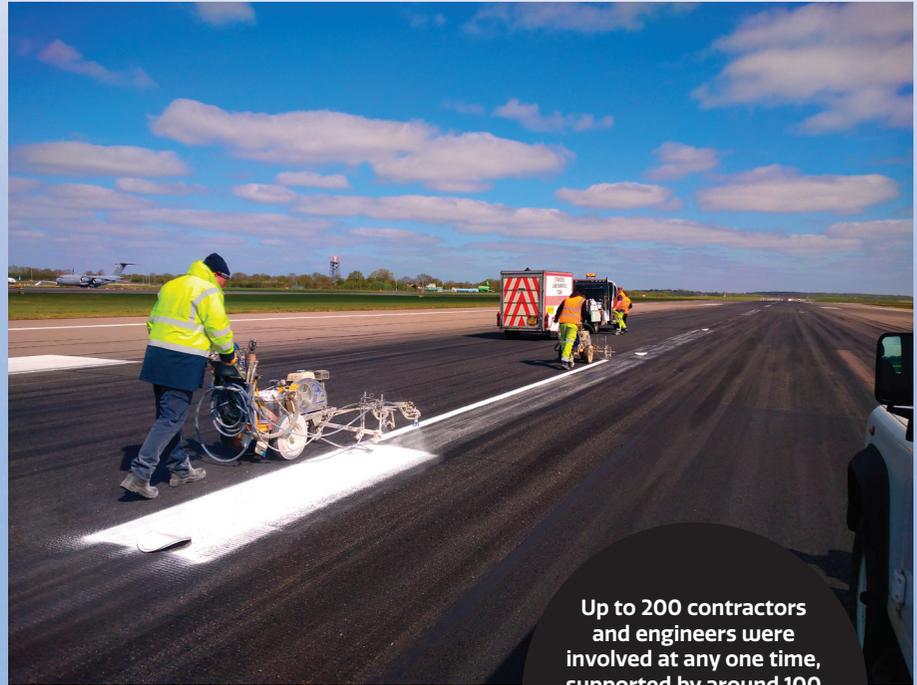
Up to 200 contractors and engineers were involved at any one time, supported by around 100 vehicles and various items of machinery, laying approximately 1,100 tons (1,000 tonnes) of asphalt

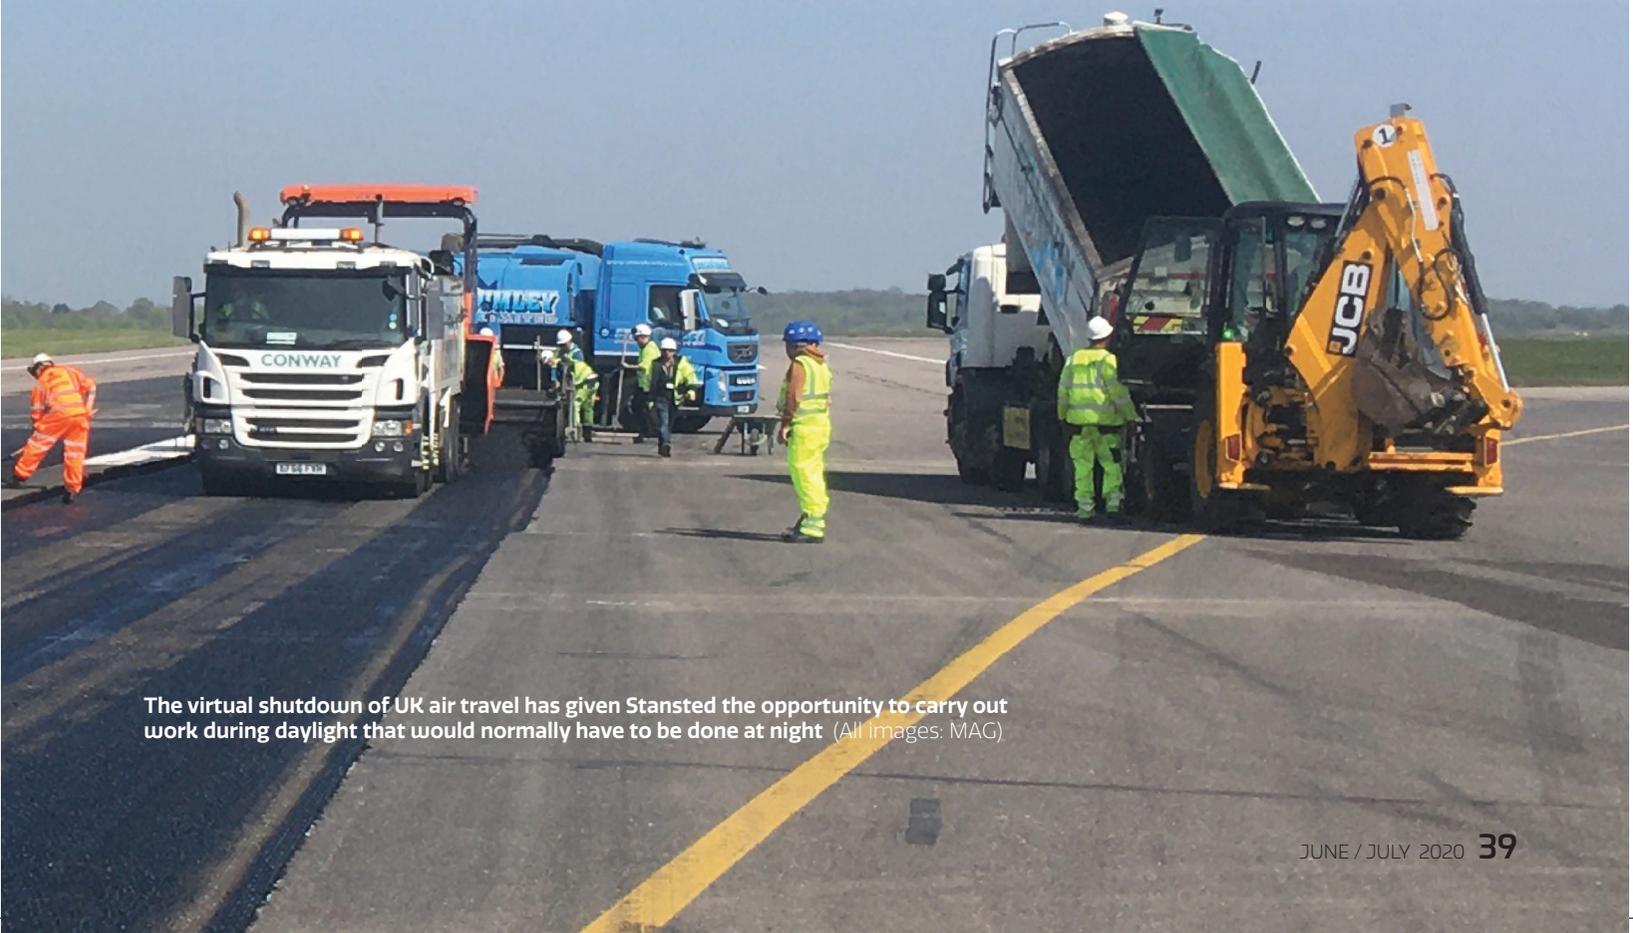
The virtual shutdown of UK air travel has given Stansted the opportunity to carry out work during daylight that would normally have to be done at night (All images: MAC)

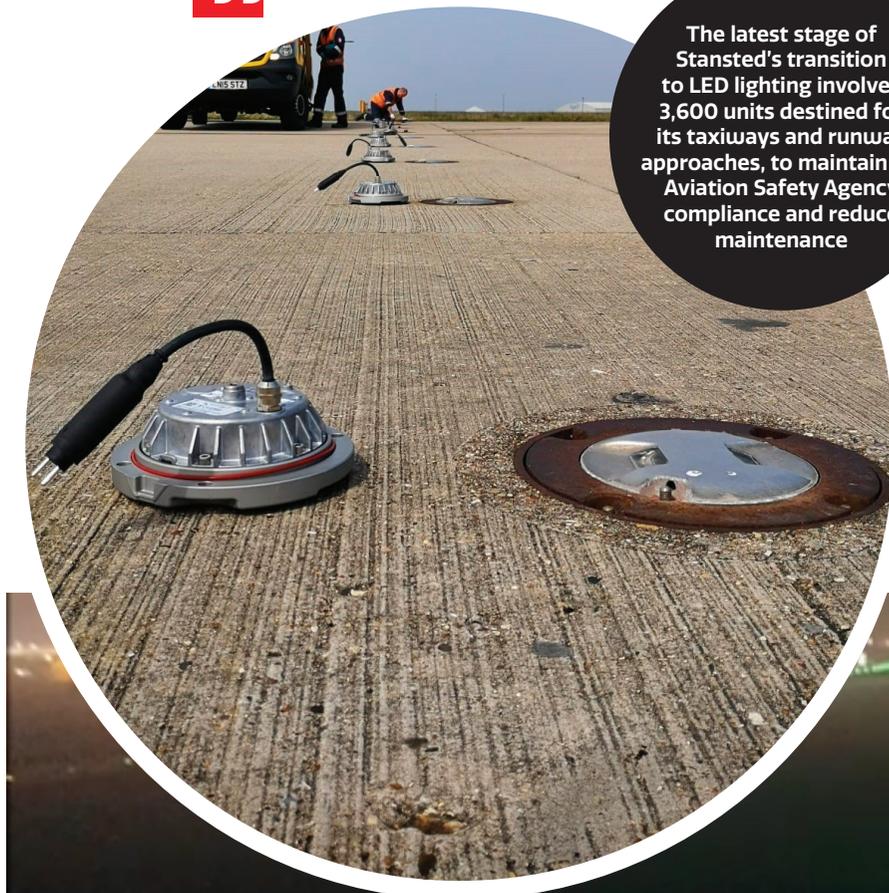
The latest stage of Stansted's transition to LED lighting involves 3,600 units destined for its taxiways and runway approaches, to maintain EU Aviation Safety Agency compliance and reduce maintenance

The increasing use of LEDs brought confidence in pushing ahead with the current stage of the lighting upgrade. The 3,600 items delivered comprised 500 lights for both CAT III approaches plus 3,100 taxiway and stop bar lights.

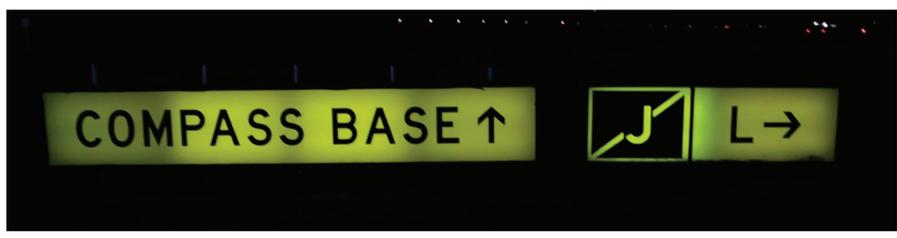
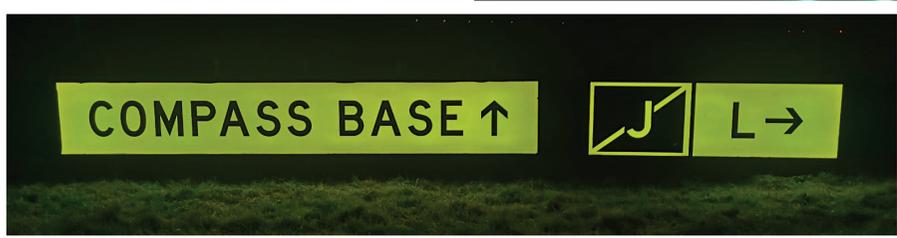
The fluorescent airfield signage (above) has now been replaced by LEDs (below)

A previously completed project involved retrofitting the airport's taxiway guidance signs with LED versions, thereby replacing fluorescent lighting technology. This was necessary to maintain European Union Aviation Safety Agency (EASA) compliance and reduce maintenance time and costs.

The project was undertaken by the airport's own electrical engineers, while TKH advised on the size of the retrofit kit required per taxiway guidance sign (TGS). The kits were preassembled in the workshop, making it possible to maximise how many signs could be swapped over per shift. It took the airport engineers no more than one hour to remove one of the old lights and fit the new LEDs on each sign in situ on the airfield.

The airport calculated that the retrofit would be less than half the cost of a complete TGS replacement project without the need for third party involvement or closures of the airfield. Around 150 signs have been retrofitted and, should any maintenance be required, an LED module or electronic driver takes less than five minutes to replace.

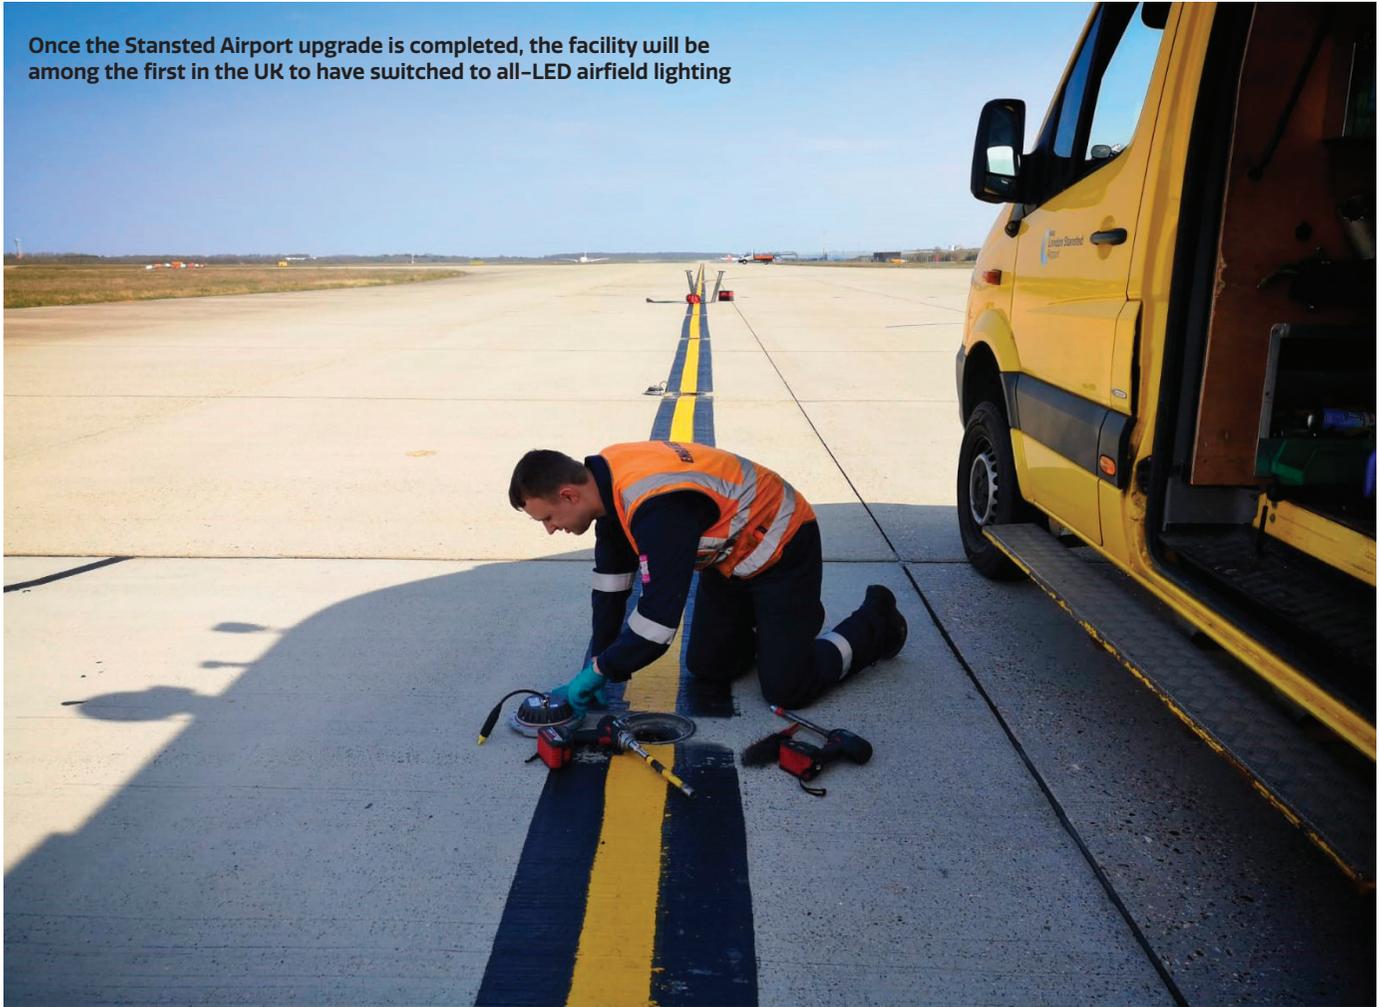
Once the Stansted Airport upgrade is completed, the facility will be among the first in the UK to have switched to all-LED airfield lighting

The new lights are currently awaiting installation and, when complete, the project will place the London airport among the first in the UK to have achieved the switch to all-LED airfield lighting. **AI**

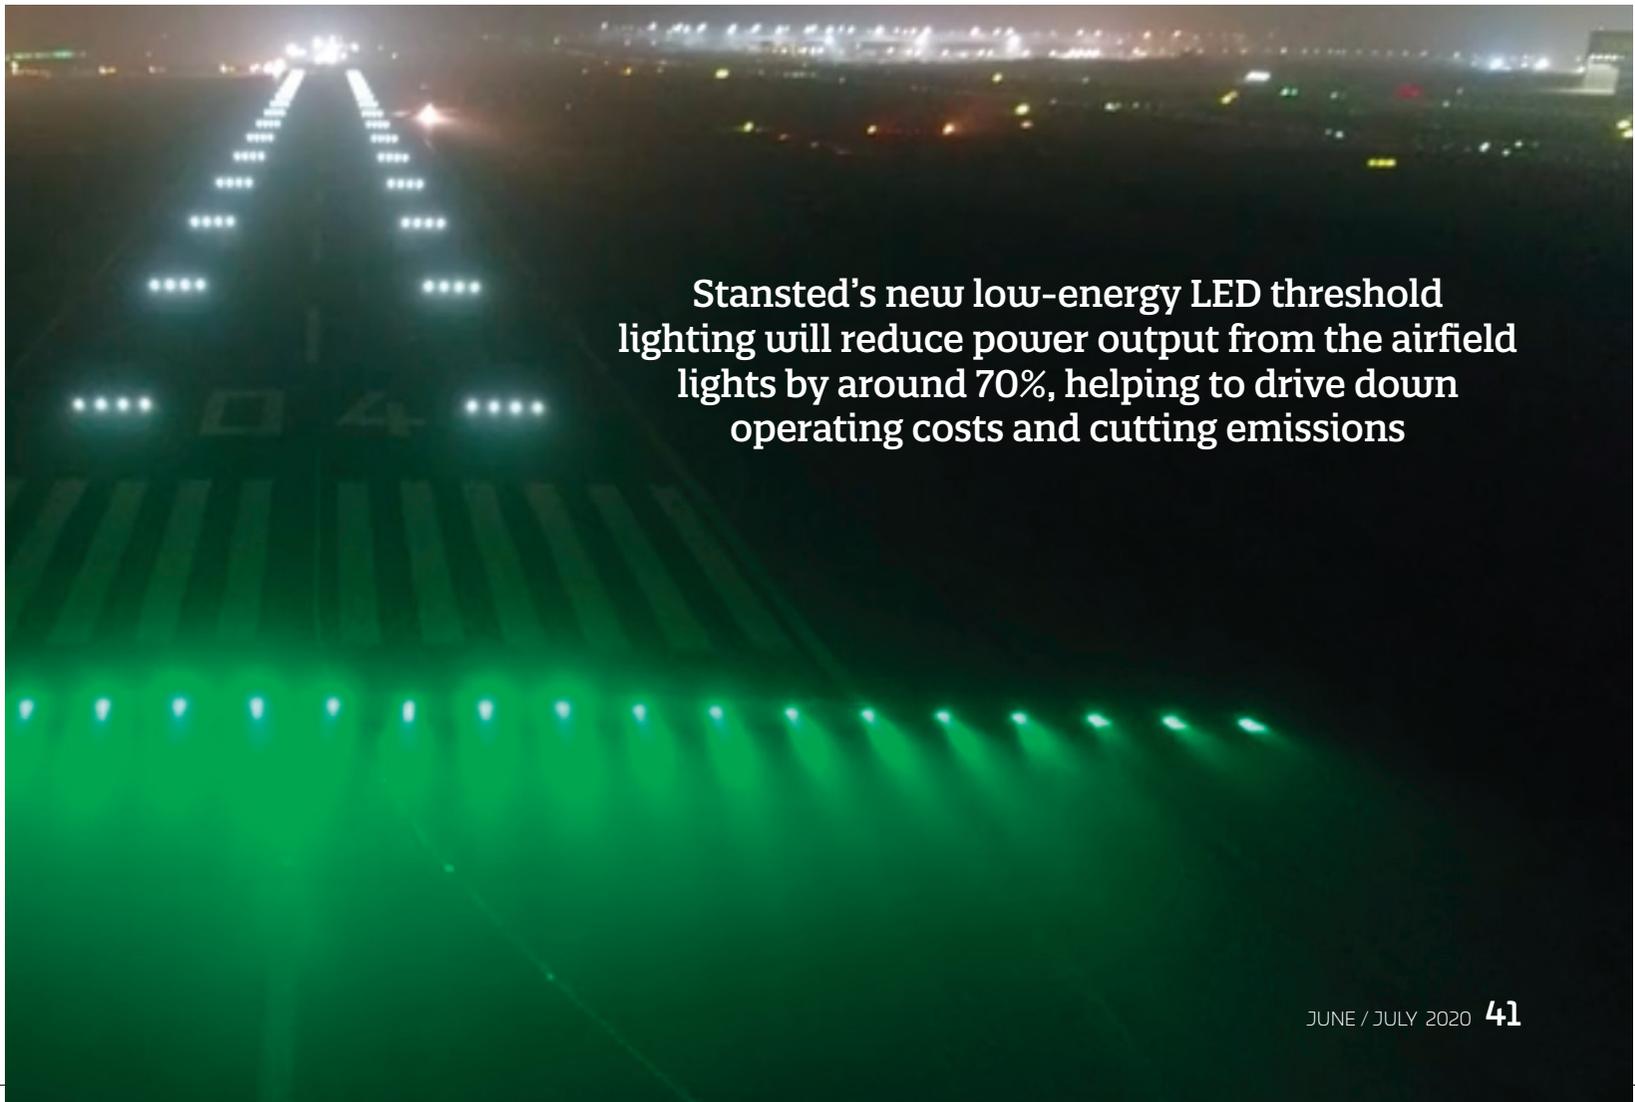
Stansted's new low-energy LED threshold lighting will reduce power output from the airfield lights by around 70%, helping to drive down operating costs and cutting emissions

It first provided Stansted with LEDs in 2019, when the runway touch-down zone and threshold lights were exchanged for LEDs. That was part of an ongoing transformation to upgrade the whole airfield to the new technology which will reduce power consumption by around 70%, helping to drive down operating costs and cut CO2 emissions.
